DEPARTMENT OF TRANSPORTATION**DIVISION OF ENGINEERING SERVICES**

Quality Assurance and Source Inspection

Contract #: 04-0120F4Cty: SF/ALA Rte: 80 PM: 13.2/13.9File #: 1.28**WELDING INSPECTION REPORT****Resident Engineer:** Casey, William**Address:** 333 Burma Road**City:** Oakland, CA 94607**Report No:** WIR-028133**Date Inspected:** 08-Aug-2012**Project Name:** SAS Superstructure**OSM Arrival Time:** 700**Prime Contractor:** American Bridge/Fluor Enterprises, a JV**OSM Departure Time:** 1930**Contractor:** American Bridge/Fluor Enterprises, a JV**Location:** Job Site**CWI Name:** As noted below**CWI Present:** Yes No**Inspected CWI report:** Yes No N/A**Rod Oven in Use:** Yes No N/A**Electrode to specification:** Yes No N/A**Weld Procedures Followed:** Yes No N/A**Qualified Welders:** Yes No N/A**Verified Joint Fit-up:** Yes No N/A**Approved Drawings:** Yes No N/A**Approved WPS:** Yes No N/A**Delayed / Cancelled:** Yes No N/A**Bridge No:** 34-0006**Component:** SAS OBG**Summary of Items Observed:**

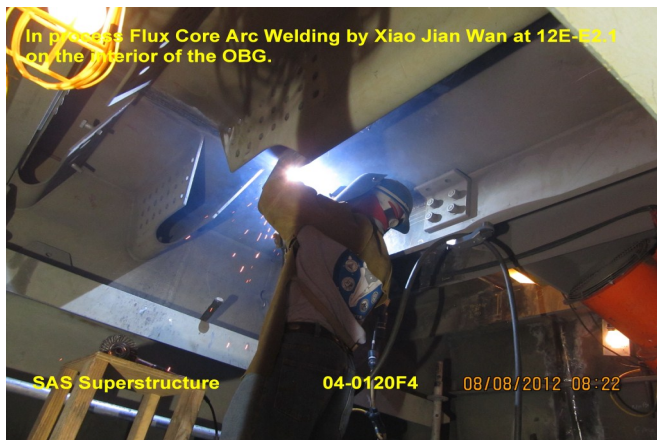
This QA Inspector randomly observed QC Inspectors Jesse Cayabyab, John Pagliero and Scott Kortum at 12E-E2.1 performing Ultrasonic Testing (UT) on the interior of the OBG. The QC Inspectors were observed scanning from each side of the weld and the scanning pattern as described in D1.5 6.24. The QC Inspectors were noted as identifying rejectable indications and the work at these locations is ongoing and appeared to be in general conformance with the contract documents and SE-UT-D1.5-CT-100-Revision 4.

The welding was performed in the overhead and vertical positions utilizing the Flux Core Arc Welding (FCAW) and Shielded Metal Arc Welding (SMAW) The welding parameters and surface temperatures were verified by the QC inspector's utilizing a Fluke 337 clamp meter to measure the electrical welding parameters and Tempil Heat Indicators for verifying the preheat and interpass temperatures. At the time of the observation no issues were noted by the QA Inspector.
